## Dome Fiberglass Summary

# Fiberglass Coupon Test Results

prepared by: Prof. Lijuan “Dawn” Cheng’s Composite Lab  
Department of Civil and Environmental Engineering, UC Davis

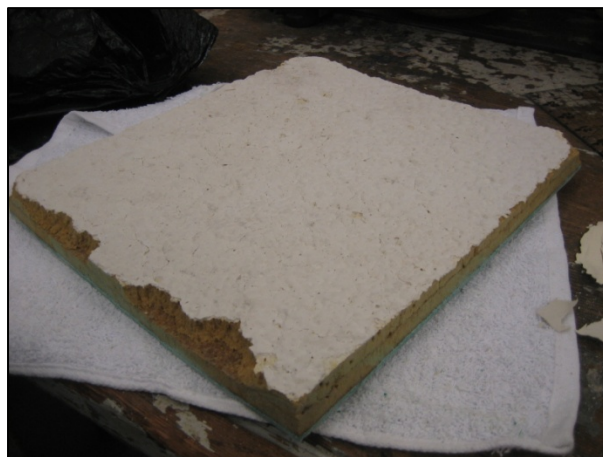
In order to test the fiberglass shell, a sample panel (10×10”) was removed from the wall of one of the domes. The raw material sample, shown in Figure 1, contained three layers. The middle layer consisted of the fiberglass material, which was made of chopped fibers and a blue-green epoxy resin. The inner and outer layers consisted of polyurethane insulation and paint, respectively.

Figure 1 - Sample panel cut from the dome

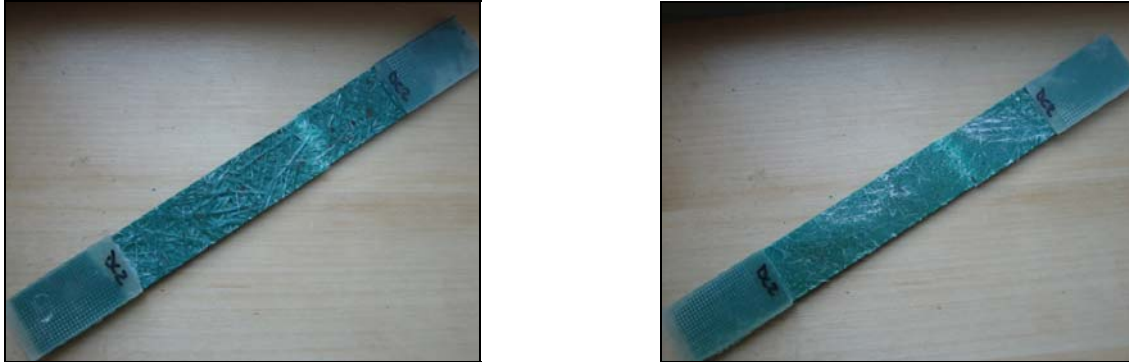
All tensile tests were conducted using an 810 Material Testing System available at CEE, shown in Figure 7. Specimens 1, 2, 3, 5, and 6, were each loaded successfully to failure (Specimen 4 failed unexpectedly due to some error). Figure 8 shows the typical failure on the front and back sides of the specimens. The test results are summarized in Table 1 below, where **the average tensile strength of the coupons was 49.03 MPa and the average tensile modulus was 7.71 GPa.**

Figure 8 - Typical tensile failure of specimens: left (front side), right (back side)
