THE DOMES STUDENT HOUSING

Field Investigation Report

DECEMBER 2010

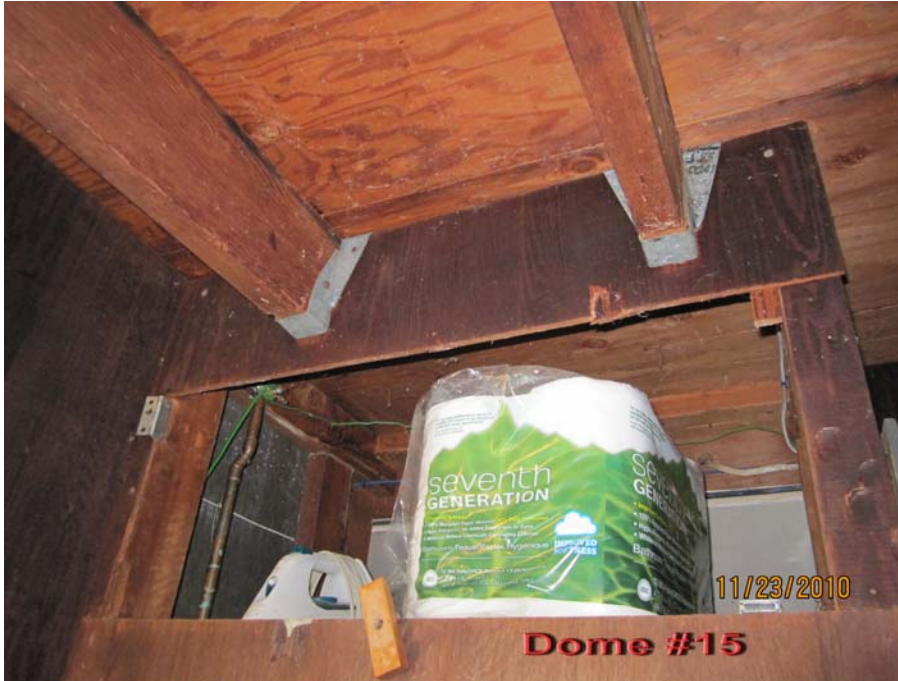
Deficiency: The pre-built interior walls were designed to be non-bearing walls hence they were built with only a single top plate. However during construction, these walls became bearing walls which supported beams and girders. See photo S-1 in Appendix A.

S-1: Dome #15, Condition A, at the hot water heater closet.

Recommendation: Bearing walls need to have double top plates. This condition appears to be the same at all of the Domes and should be further investigated and remedied.

11/16/2010	15	<ul style="list-style-type: none"> Add double top plates to load bearing interior walls. 	<ul style="list-style-type: none"> Install bathroom exhaust fan. Replace roof top turbine ventilator Suggested Energy Improvements: <ul style="list-style-type: none"> Seal building envelope to correct air leakage Upgrade to double-pane windows Improve wall insulation 	<ul style="list-style-type: none"> Insulate piping Install piping supports. Install proper type of backflow preventer Add access panels for valves. Install vacuum breaker on exterior (wall?) hose bib. Add seismic bracing to hot water tank. 	<ul style="list-style-type: none"> Cover enclosure at stove to conceal wall heater wiring. Add GFI protection to kitchen outlets at counter area. Evaluate smoke detector and replace if defective. Add Arc-Fault Circuit-Interrupter protection to bedroom circuits.

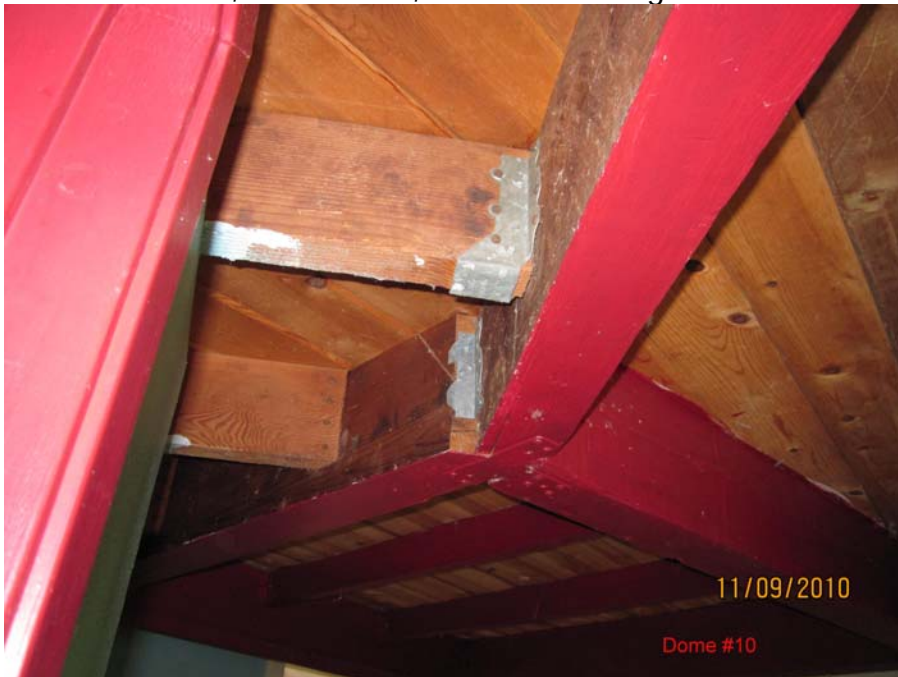
Deficiency: Support columns were found missing at the intersection of multiple floor girders at Dome #10 and at Dome #12. See photos S-2 and S-3 in Appendix A.

S-2: Dome #10, Condition B, Intersection of girders.

Recommendation: The columns should be reinstalled, or, because the girders are probably supported by cantilever beams projecting out from the top of interior walls, a more detailed structural analysis is needed to identify the load path and make sure that beam hangers are provided, in lieu of toe nailing.

7/14/10	10	<ul style="list-style-type: none"> Repair delamination on exterior shell. Columns should be reinstalled with beam hangers at the intersection of multiple floor girders. More detailed investigation of structural integrity of bedroom loft recommended. 	<ul style="list-style-type: none"> Install bathroom exhaust fan. Replace roof top turbine ventilator Suggested Energy Improvements: <ul style="list-style-type: none"> Seal building envelope to correct air leakage Upgrade to double-pane windows Improve wall insulation Install metal ventilating hood above the cooking surface OR remove kitchen cabinet above range. 	<ul style="list-style-type: none"> Insulate piping. Install piping supports. 	<ul style="list-style-type: none"> Add GFI protection to kitchen outlets at counter area. Add GFI protection for bathroom outlets. Add Arc-Fault Circuit-Interrupter protection to bedroom circuits. Install Smoke detector in loft bedroom area.

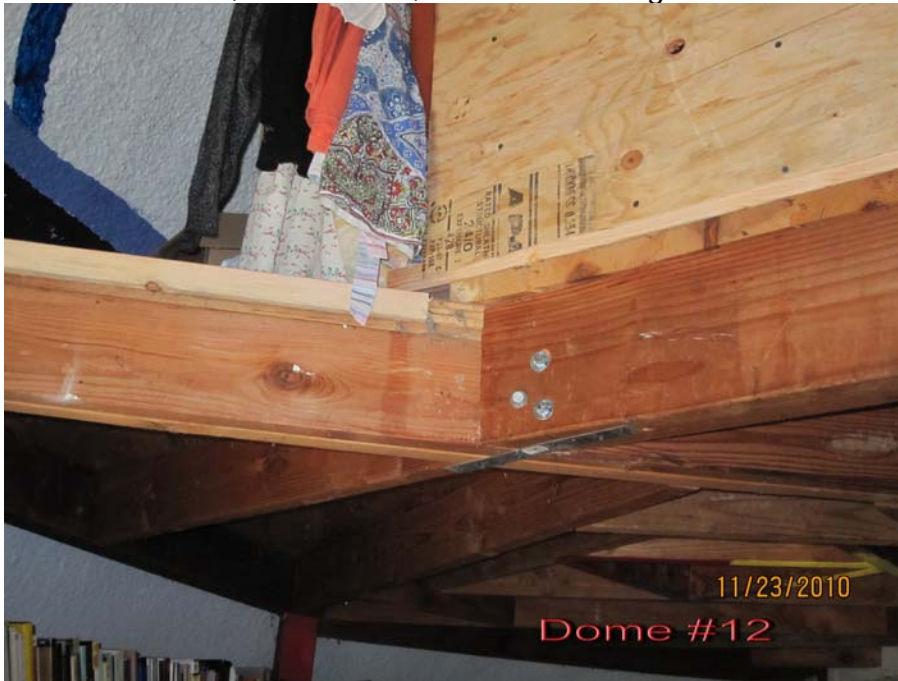
S-3: Dome #12, Condition B, Intersection of girders.

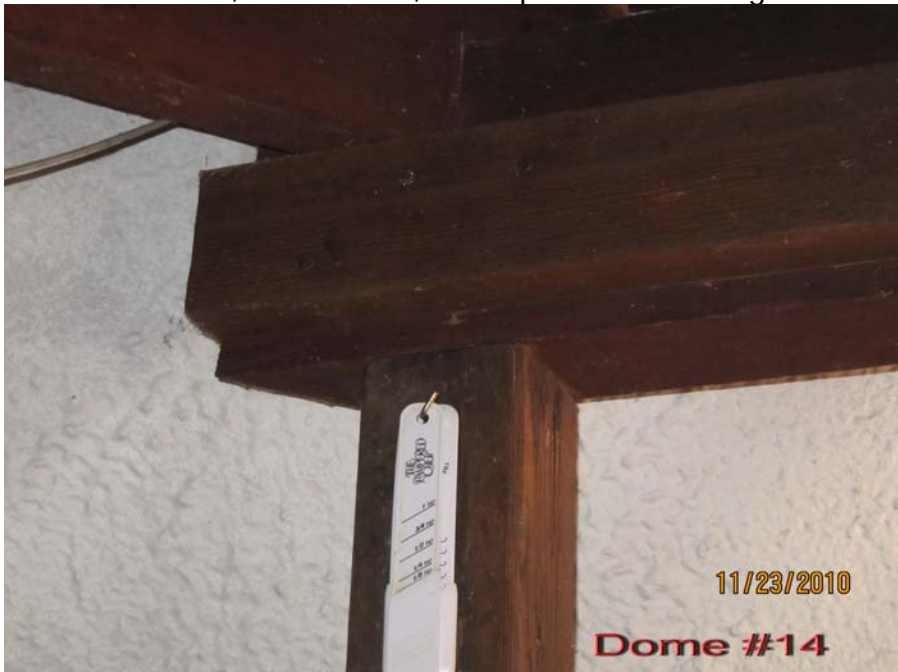
Deficiency: Most of the column to girder connections were found to have adequate metal connection plates/ties but some columns were found to have minimal connection supporting the girder, at the top of the column. See photo S-4 in Appendix A. Some were toe nailed and some had insufficient metal straps.

S-4: Dome #14, Condition C, inadequate column to girder connection

Recommendation: A more detailed investigation should be done at each Dome and metal connections should be added at places where only toe nails are found.

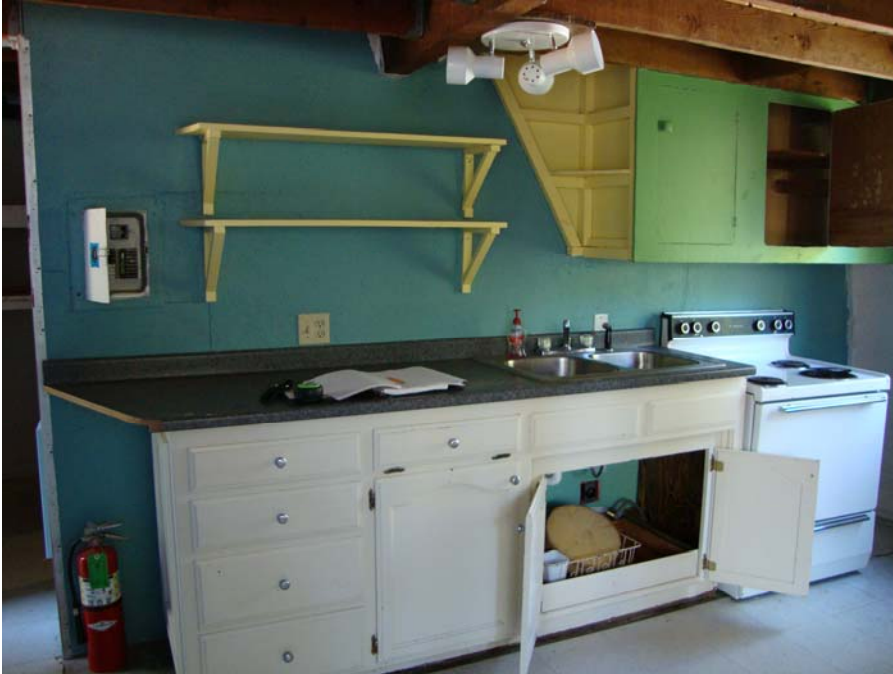
Deficiencies: 2007 California Building Code (CBC), Section 1203.4.2.1 requires bathrooms to be mechanically ventilated, all Dome bathrooms are not in compliance. 2007 California Mechanical Code (CMC), Section 916.1 (B) requires mechanical ventilation above the cooking range when combustible material is directly located above it, such as in Dome #10, see photo M-1 in Appendix A, the current kitchen ventilation in this dome is not in compliance.

M-1: Dome #10, combustible material above cooking range.

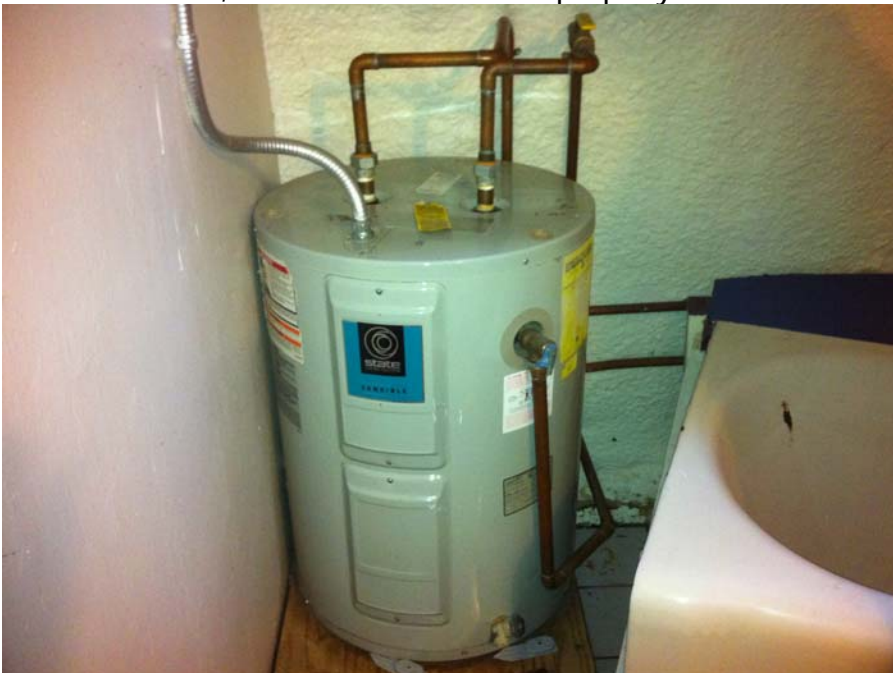
Deficiencies: Per 2007 CMC, Section 508.2 the water heater tanks in the majority of the domes are not properly supported for seismic protection, see photo M-2 in Appendix A. In almost half of the domes, the sanitary sewer vent pipe exits the exterior wall horizontally as in Dome #3, see photo M-3 in Appendix A. Vent pipes must be terminated vertically through the wall as required in 2007 CMC, Section 906.1. There is a hose bib connection for each Dome; however the hose connection is missing the proper type of backflow preventer as indicated in 2007 CMC, Section 603.2.3, see photo M-4 in Appendix A. Installation of backflow prevention devices must be approved by the Authority Having Jurisdiction and be tested by a Certified Backflow Assembly tester. If required by Authority Having Jurisdiction also provide protection for freezing.

M-2: Dome #4, water heater tank not properly braced.

11/9/2010	4	<ul style="list-style-type: none"> More detailed investigation recommended to confirm actual construction of bearing wall top plates, support columns, and connections. 	<ul style="list-style-type: none"> Install bathroom exhaust fan. Replace roof top turbine ventilator Suggested Energy Improvements: <ul style="list-style-type: none"> Seal building envelope to correct air leakage Upgrade to double-pane windows Improve wall insulation 	<ul style="list-style-type: none"> Install proper type of backflow preventer. Install vacuum breaker on exterior hose bib. Reroute vent piping to terminate vertically through wall. Add seismic bracing to hot water tank. 	<ul style="list-style-type: none"> Add GFI protection to kitchen outlets at counter area. Add Arc-Fault Circuit-Interrupter protection to bedroom circuits.
11/9/2010	5	<ul style="list-style-type: none"> More detailed investigation recommended to confirm actual construction of bearing wall top plates, support columns, and connections. 	<ul style="list-style-type: none"> Install bathroom exhaust fan. Replace roof top turbine ventilator Suggested Energy Improvements: <ul style="list-style-type: none"> Seal building envelope to correct air leakage Upgrade to double-pane windows Improve wall insulation 	<ul style="list-style-type: none"> Insulate piping Install piping supports. Install proper type of backflow preventer. 	<ul style="list-style-type: none"> Add GFI protection to kitchen outlets at counter area. Replace 6-plug capacity outlet at right side of kitchen sink with regular duplex outlet. Add Arc-Fault Circuit-Interrupter protection to bedroom circuits.

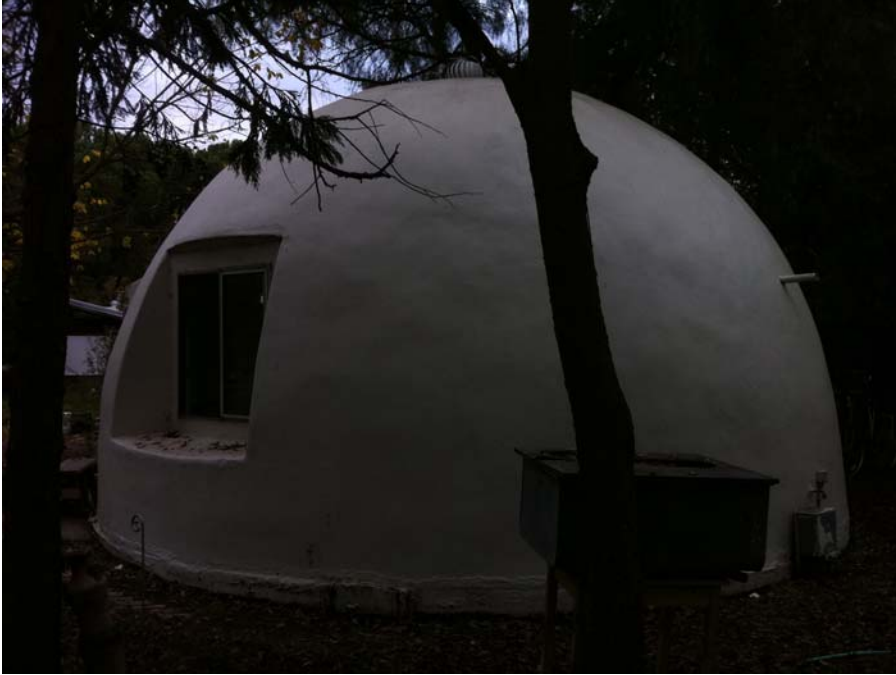
M-3: Dome #3, horizontal termination of sanitary sewer vent piping.

11/9/2010	3	<ul style="list-style-type: none"> More detailed investigation recommended to confirm actual construction of bearing wall top plates, support columns, and connections. 	<ul style="list-style-type: none"> Install bathroom exhaust fan. Replace roof top turbine ventilator Suggested Energy Improvements: <ul style="list-style-type: none"> Seal building envelope to correct air leakage Upgrade to double-pane windows Improve wall insulation 	<ul style="list-style-type: none"> Insulate Piping. Install proper type of backflow preventer. Reroute vent piping to terminate vertically through wall. Add seismic bracing to hot water tank. 	<ul style="list-style-type: none"> Install cover for LB type fitting for conduit penetrating the wall. Add GFI protection and waterproof cover for duplex receptacle mounted at base of bathroom floor, OR eliminate completely if not in use. Add GFI protection to kitchen outlets at counter area. Add Arc-Fault Circuit-Interrupter protection to bedroom circuits.

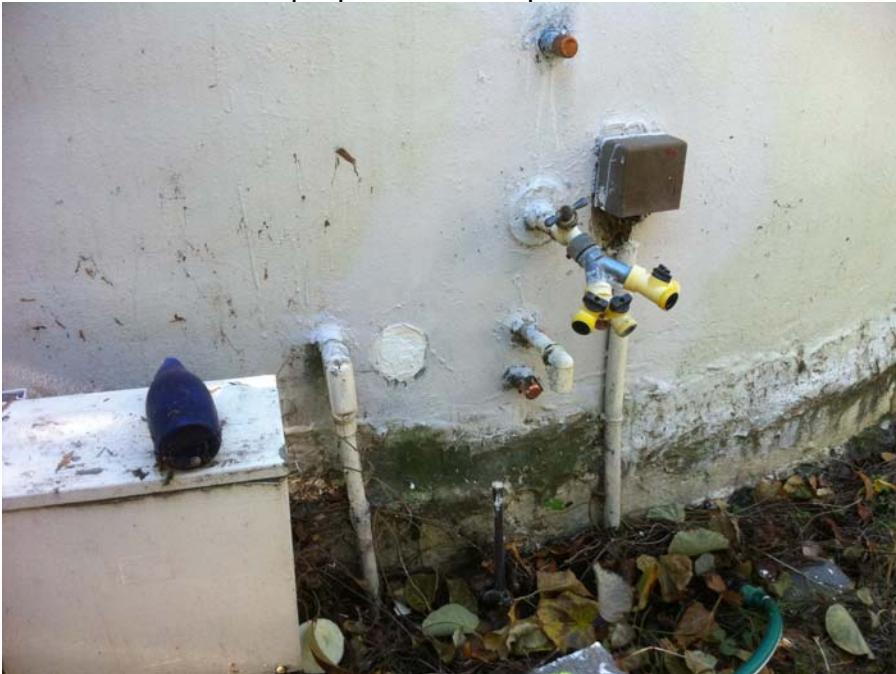
M-4: Dome #12, improper backflow prevention device.

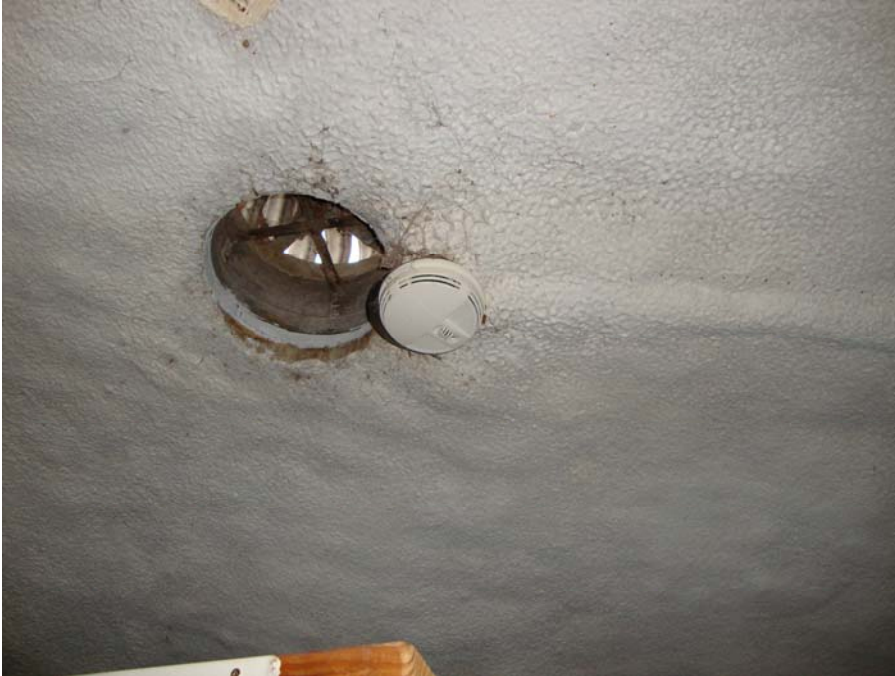
Each Dome was constructed to comply with the National Electrical Code requirements for residential wiring in the 1972 time period. Electrical service is fed to the site via the Campus 12.47KV medium voltage distribution system and a pad mounted transformer that steps it down to 120/208-volt system with distribution to each Dome. Each Dome has a 100-amp main circuit breaker panel with branch breakers serving the dome. At the peak of the Dome, there is a smoke detector adjacent to the turbine ventilator that might be exposed to water damage during heavy rain pour that the Fire Department is recommending to relocate away from the ventilator, see photo E-1 in Appendix A.

E-1: Dome #5, Smoke detector vulnerable to water damage.

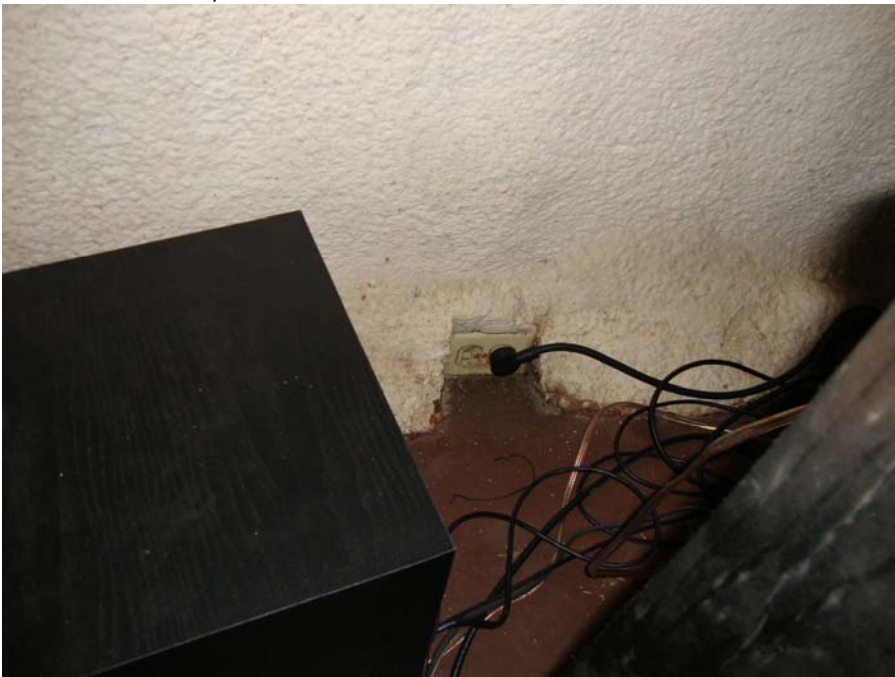
Deficiencies: Conditions within the electrical system that are not in compliance with the 2007 National Electrical Code (NEC) are Ground-Fault Circuit-Interrupter (GFCI outlets) protection in the Kitchen (NEC-210.8), and Arc-Fault Circuit-Interrupter protection of circuits serving bedrooms (NEC-210.12). Outlets were located near and on the floor throughout the Domes, although NEC does not

require minimum mounting heights of plug outlets, The Americans with Disabilities Act (ADA) will dictate the minimum height of outlets for compliance, see photo E-2 in Appendix A.

E-2: Dome #3, electrical outlet located at floor
