RE: July 14, 2010 Inspection of Baggins End Dome # 10

On Wednesday, July 14, 2010 at the Request of Student Housing and as part of a joint inspection team that included UCD Fire, Design and Construction Management and Facilities Services, Susan Cummings, Claire Denham and Sue Fields of EH&S performed an inspection of the unoccupied Dome 10 in Student Housing's Baggins End Housing Area.

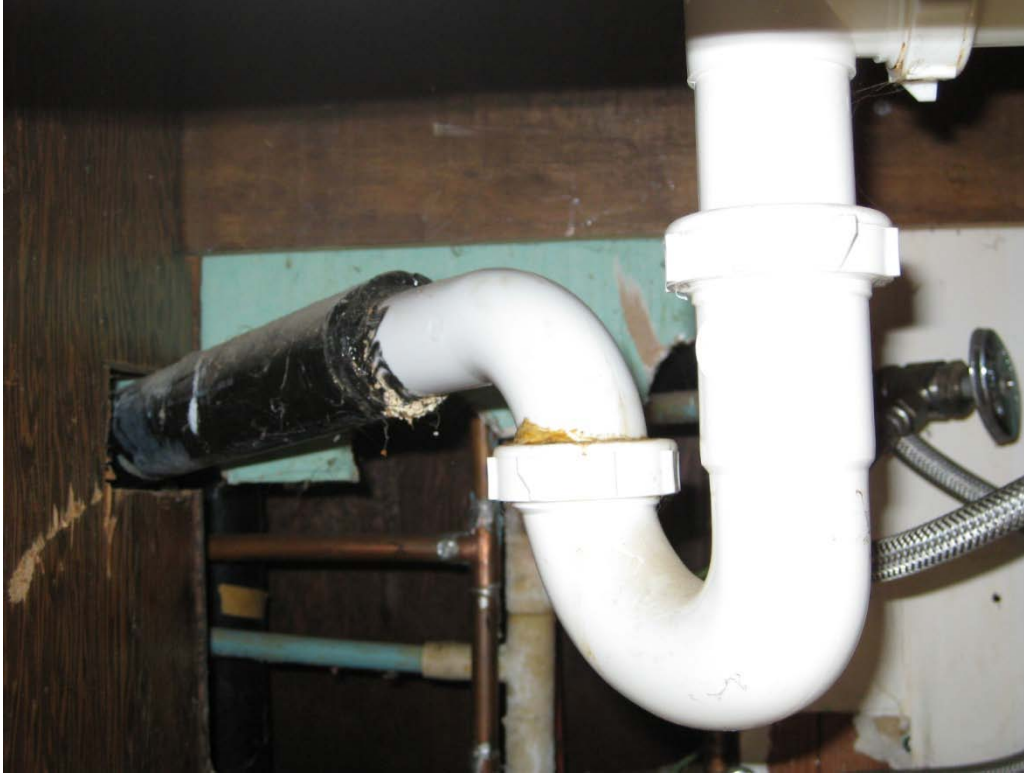
Picture 1: Kitchen Sink

1. Area is approximately 98 sq ft space. Screened window meets minimum 1 sq. ft. size requirement
2. Sheetrock removed from wall beneath kitchen sink to access plumbing lines to bathroom and kitchen. (Picture 1 Kitchen Sink)
Corrective Action:
Replace sheetrock or consider installing an access panel for future plumbing repairs
3. ****Leaking domestic water supply pipe noted at pipes located beneath the kitchen sink and in the space between the kitchen and bathroom walls (Picture 1: Kitchen Sink; pipe behind P-trap)**
Corrective Action:

4. ****Silicone (or similar material) is not an approved method for joining two pieces of (sanitary) discharge pipes (Picture 1: Kitchen Sink) –**

Retain the services of a State licensed plumber or a plumber approved by Student Housing or the campus Plumbing Shop for an approved repair method. Also, determine if existing pipes meet code for conveyance of domestic water. If they do not, please replace with pipes made of approved materials.

Retain the services of a State licensed plumber or a plumber approved by Student Housing or the campus Plumbing Shop to obtain an approved method for pipe joining and to find out pipe materials approved for this type of discharge and replace existing if necessary.

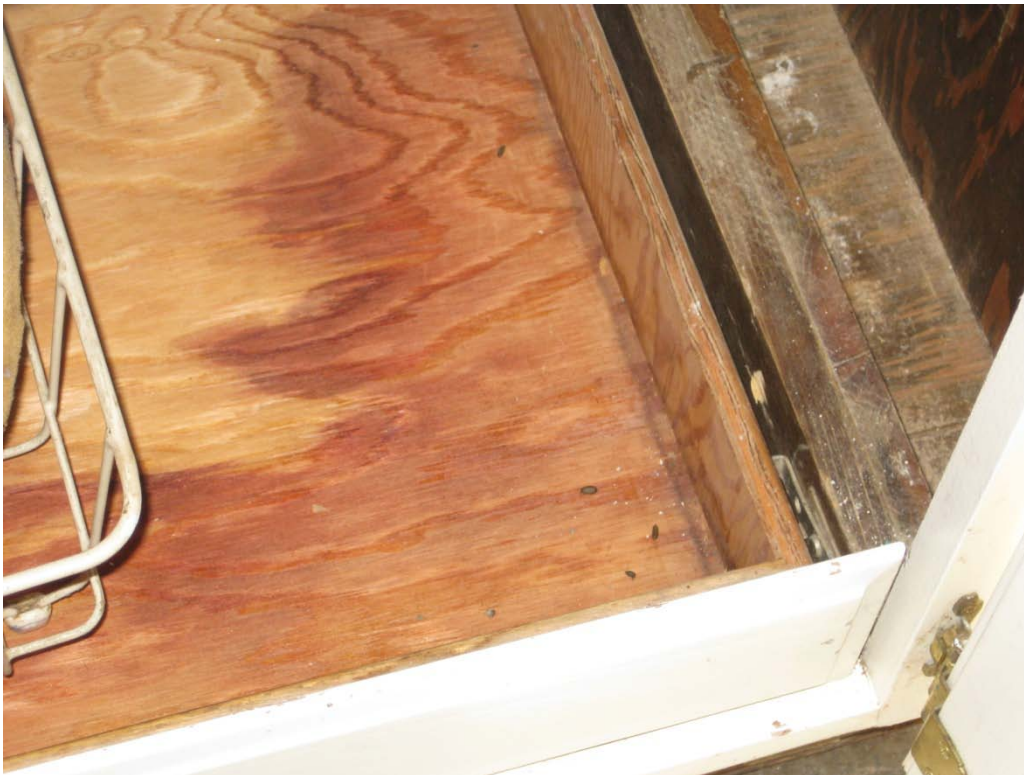
Picture 2: Rat Droppings

5. ****Rat droppings were noted in the drawer located on the bottom shelf in the cabinet beneath the sink/sink counter (Picture 2: Rat Droppings)**

Carefully remove and dispose of droppings. Wash and sanitize the drawers. To prevent further/ongoing pest problems, identify and secure all potential rodent entry points.

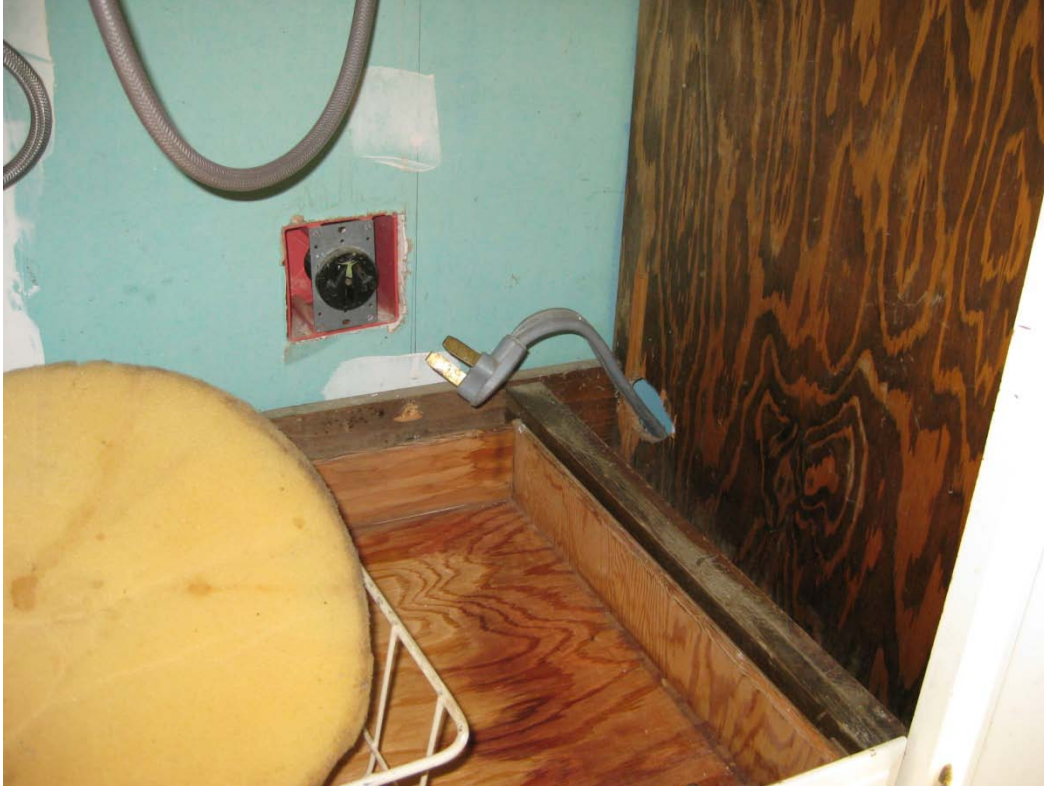
Picture 3: Outlet 1

6. ****The electrical outlet (220?) for the stove is located beneath the kitchen sink lacks a plate cover thereby exposing wiring. (Picture 3: Outlet 1)**

Retain the services of a State licensed electrician, or an electrician from, or approved by Student Housing or the campus Electrical Shop to determine if electrical outlet is properly installed and in good repair. If so, or after making needed repairs, install outlet cover.

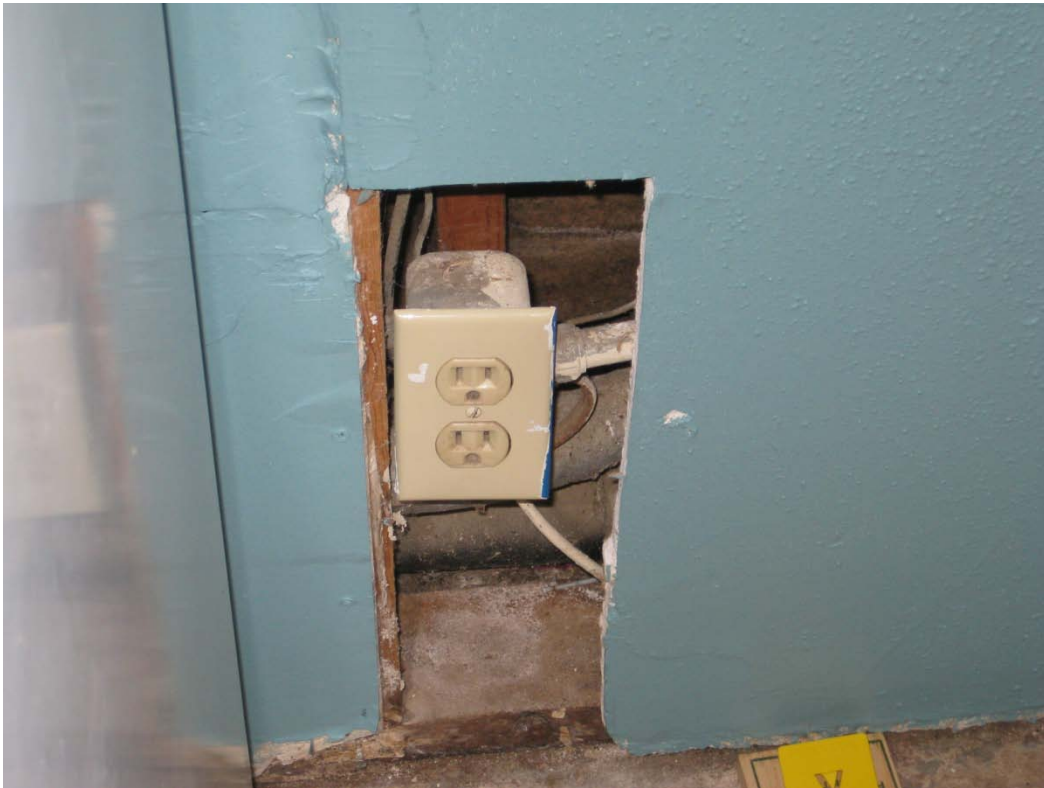
Picture 4: Outlet 2

7. ****Wall covering (sheetrock) has been removed from the area around and beneath a 110 duplex electrical outlet that is located approximately six inches above the floor surface and to the right of the stove. (Picture 4: Outlet 2)**

Retain the services of a State licensed electrician, or an electrician from, or approved by Student Housing or the campus Electrical Shop to determine if electrical outlet is properly installed and in good repair. If so, or after making it so, replace sheetrock and seal/paint patch and wall.

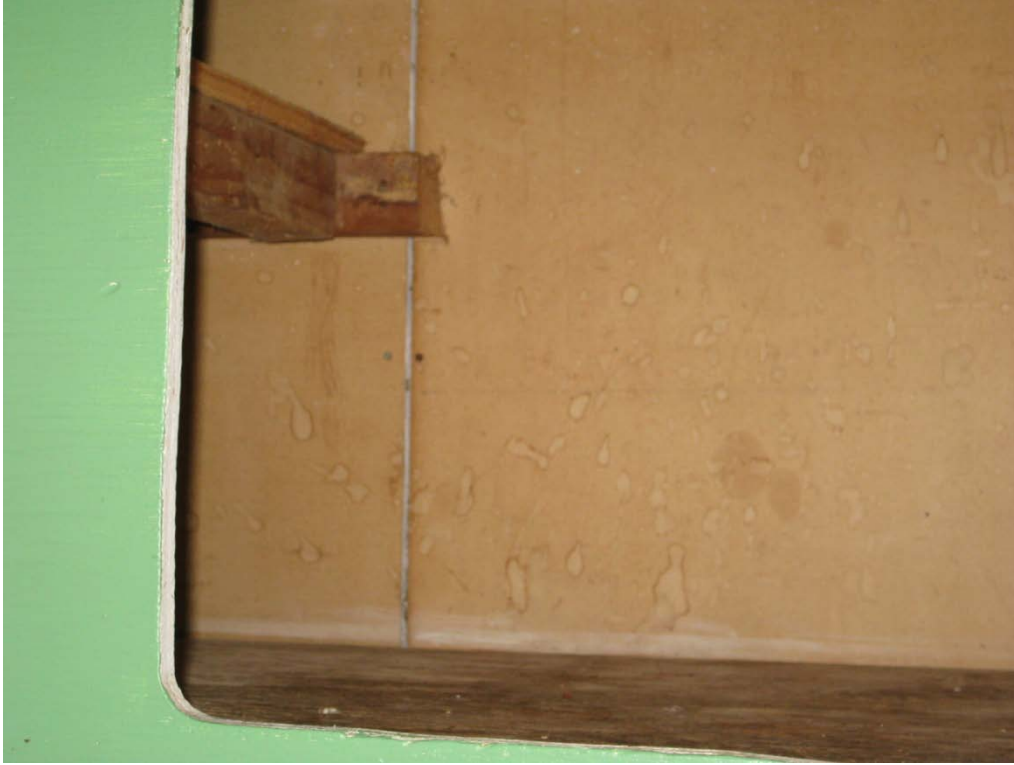
Picture 5: Cabinets

8. **Raw/Unsealed wood and sheetrock noted in kitchen cabinets. (Picture 5: Cabinets)**

Seal/Paint sheetrock and wood to enable cleaning

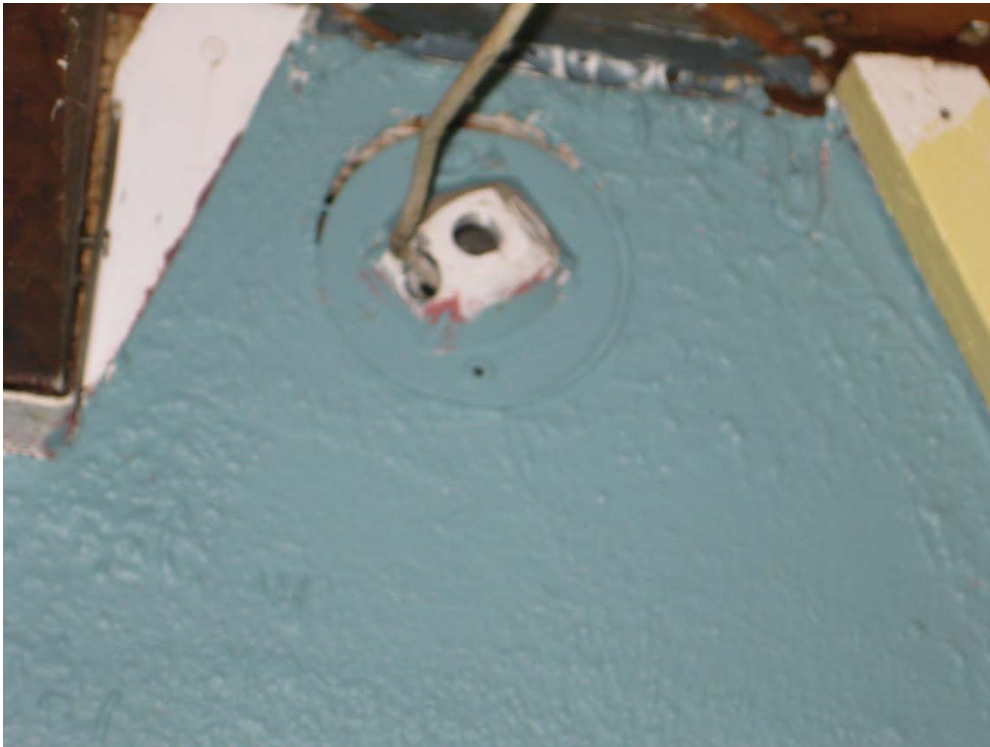
Picture 6: Ceiling Light Fixture Connection

10. ****Ceiling light fixture connection to electrical supply appears not conform with Electrical Code.** (Picture 6: Ceiling Light Fixture Connection)

Retain the services of a State licensed electrician, or an electrician from, or approved by, Student Housing or the campus Electrical Shop to make needed repairs.

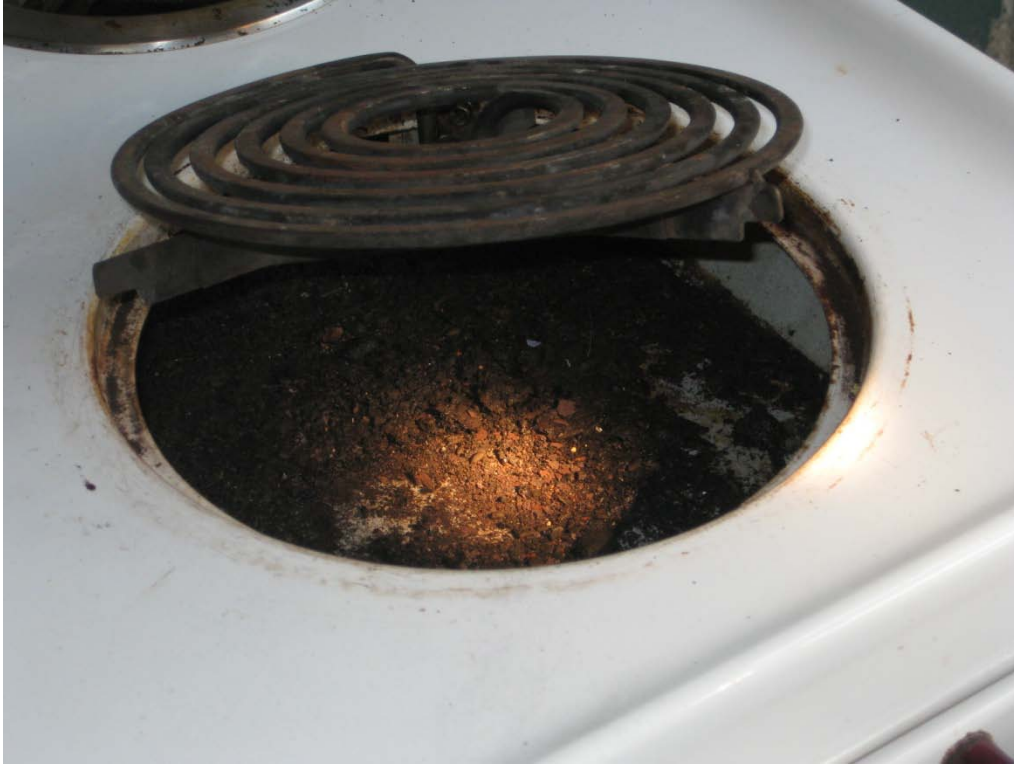
Picture 7: Stove

11. Food overspill accumulation noted in oven and beneath the range top drip pans (Picture 7: Stove)

NOTE: Food spill accumulations attract and provide sustenance for rodents and pests.

Clean food spill accumulations

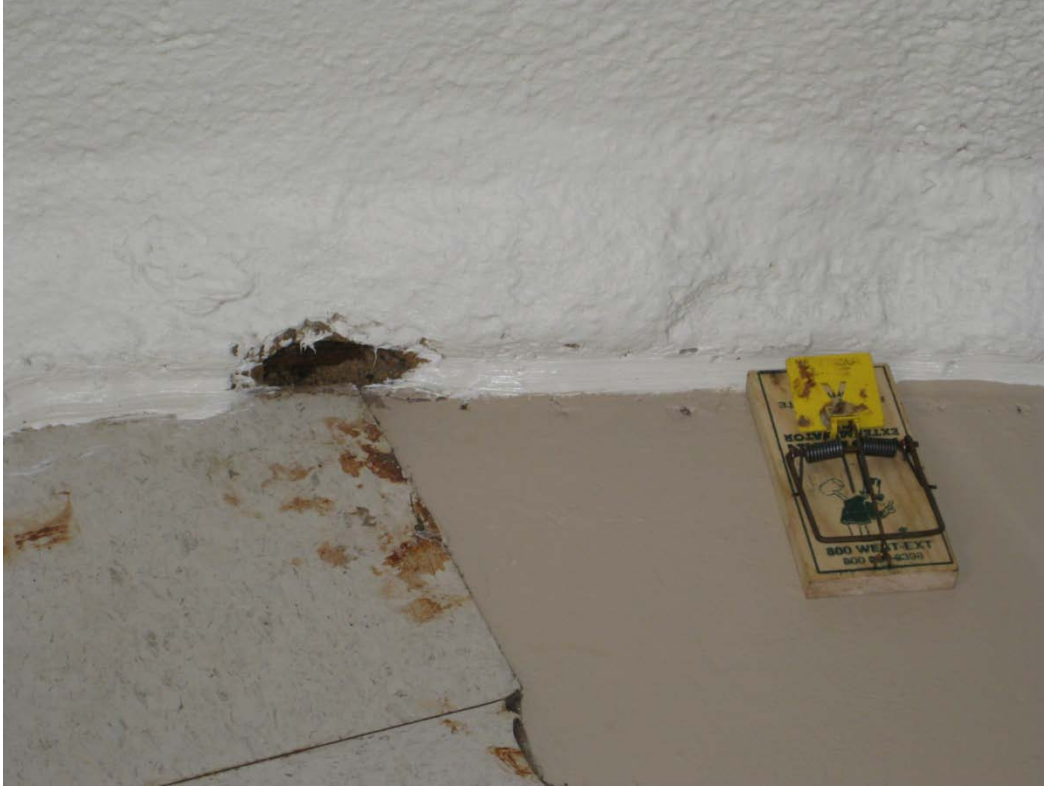
Picture 8: Wall

12. There are several holes in walls at the wall – floor juncture. (Picture 8: Walls)

NOTE: These opening provide access for rodents, insects and other pests.

Patch holes and seal/paint patches.

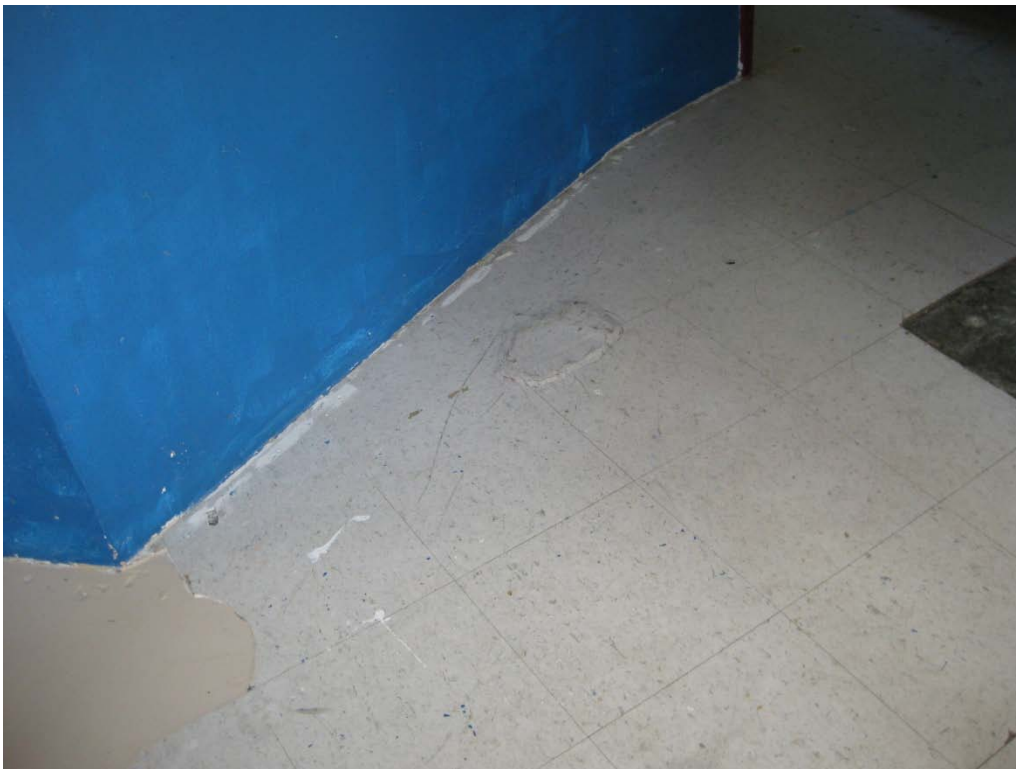
Picture 9: Floor

16. Section of concrete floor in hallway is elevated indicating moisture intrusion. (Picture 9: Floor)

Identify reason for elevated concrete and repair as needed. Replace any removed floor covering.

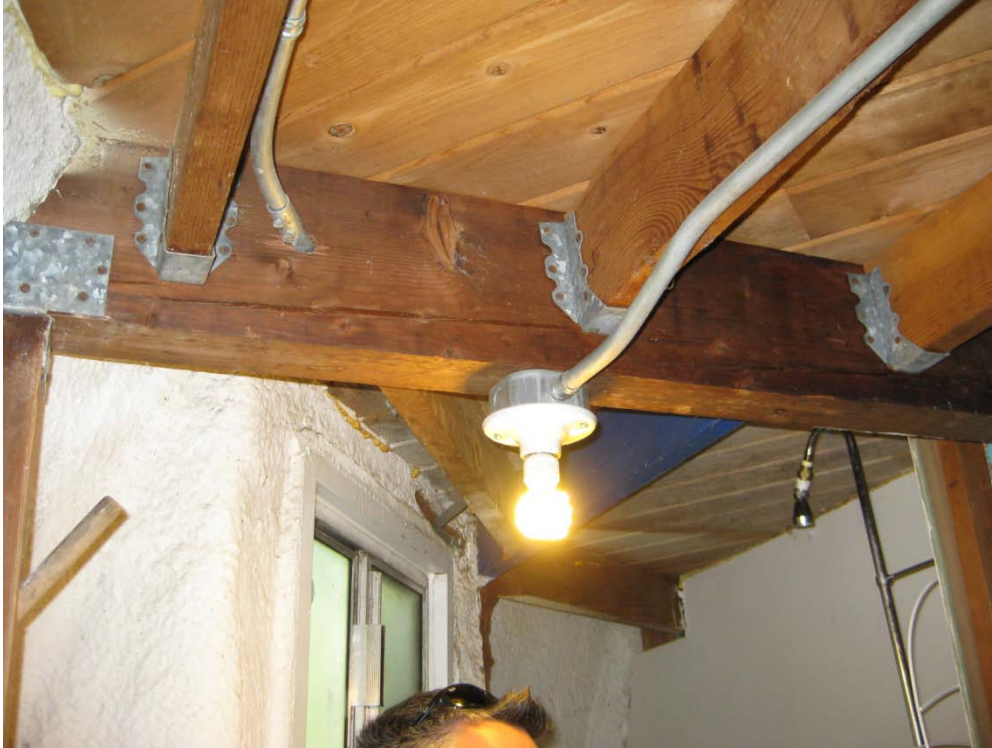
Picture 10: Uncovered Bulb

2. Room's ceiling light fixture uses a CFL bulb with no covering or shield. (Picture 10: Light Fixture)
Corrective Action:
Install appropriate bulb shield.

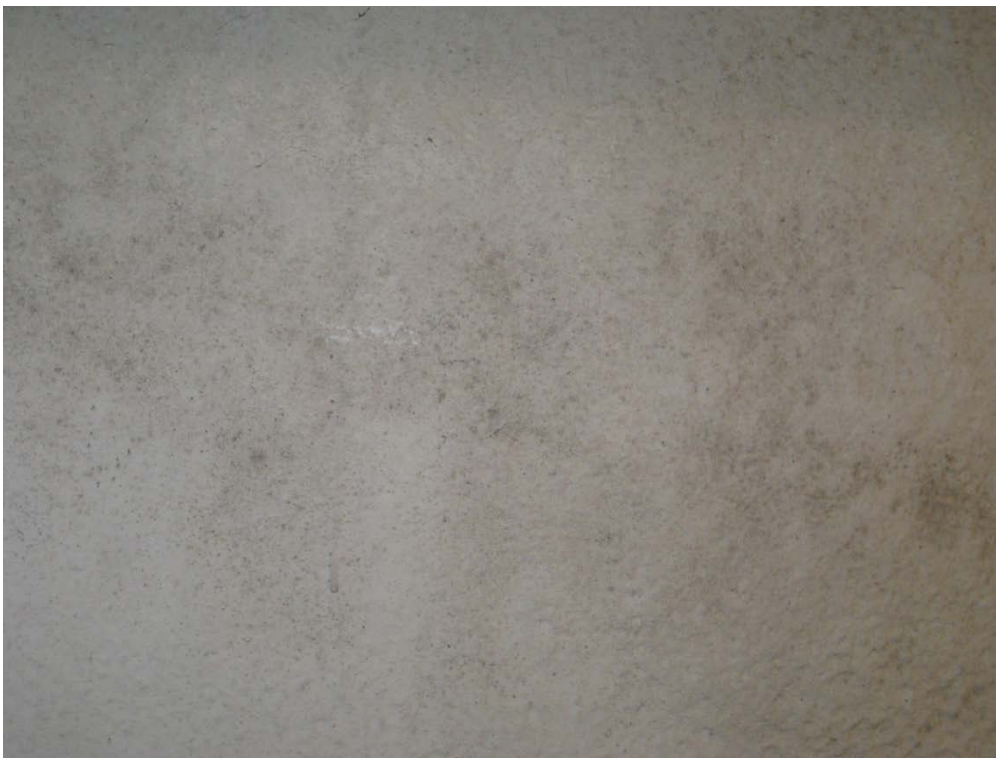
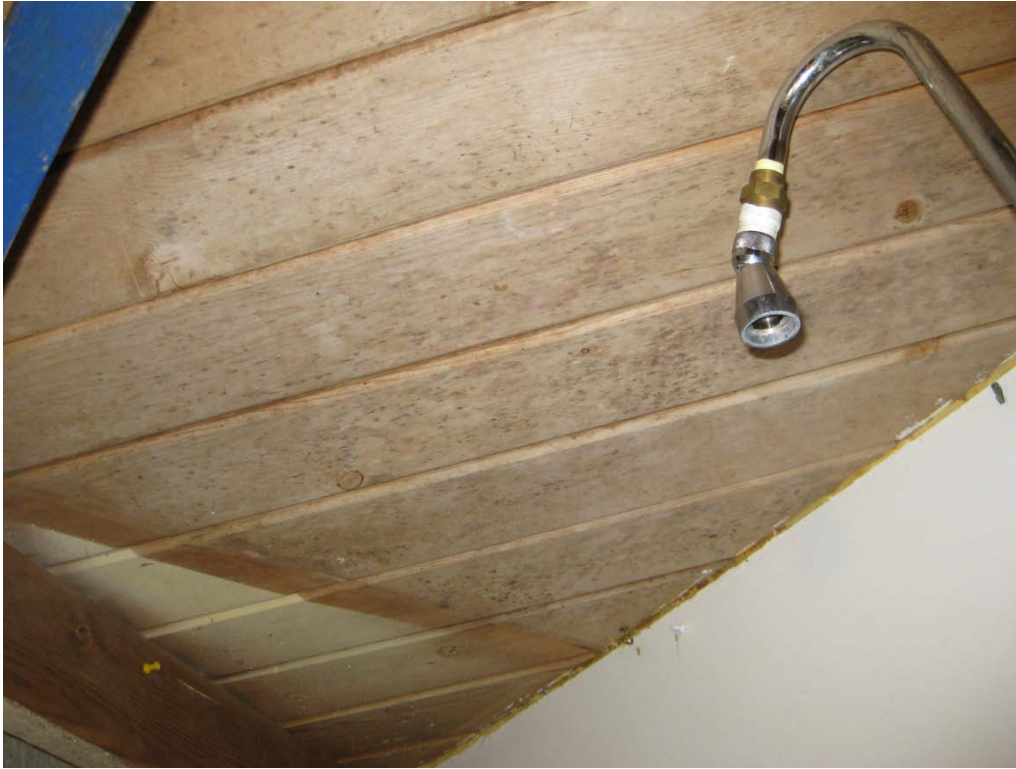
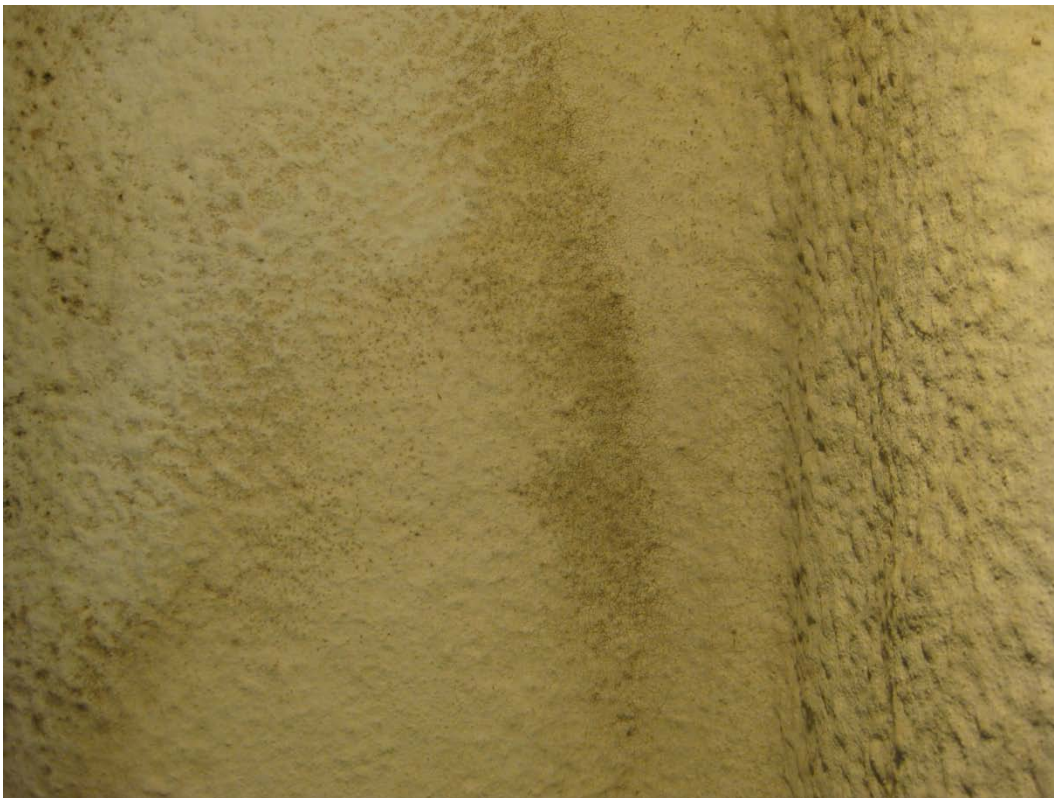
3. ****Mold growth noted on walls and ceiling. (Pictures 11-13)**
Corrective Action:
If mold has not grown into wall material, clean walls then bleach until mold and spores are destroyed. If mold has grown into the base wall material, remove material see <http://www.nyhealth.gov/environmental/indoors/air/mold.htm> for guidance.

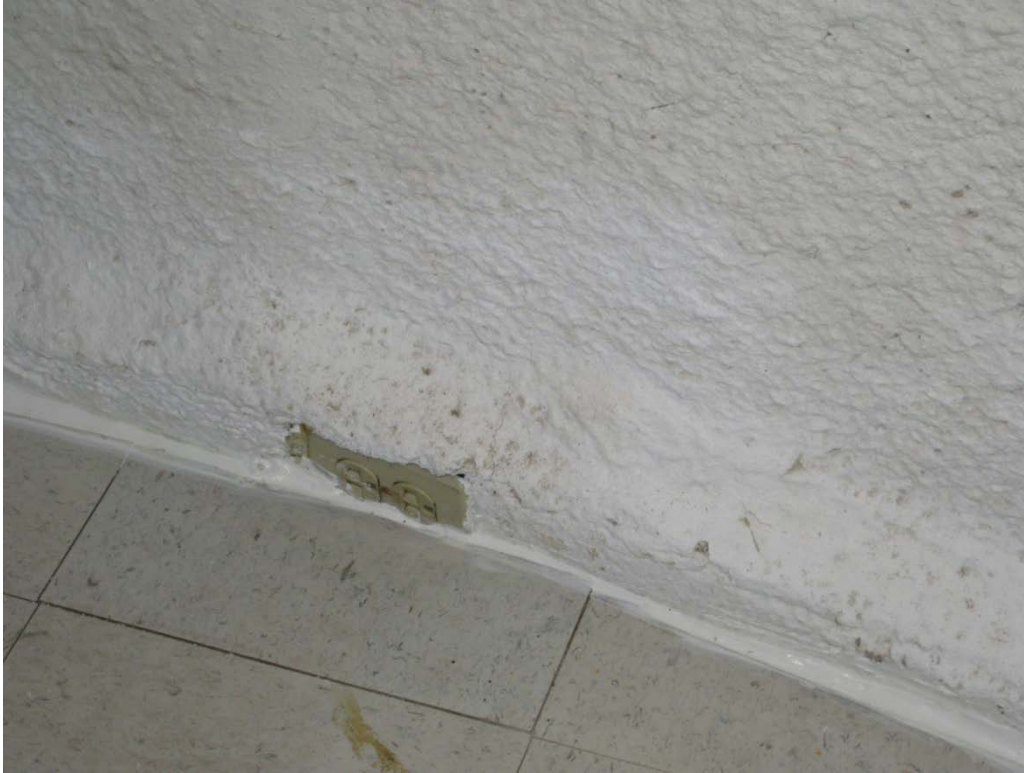
Picture 14: Outlet 4

4. Wall outlet at wall-floor juncture, is partially buried. (Picture 14: outlet).
Corrective Action:
Retain the services of a State licensed electrician, or an electrician from, or approved by Student Housing or the campus Electrical Shop who will properly locate the electrical outlet.

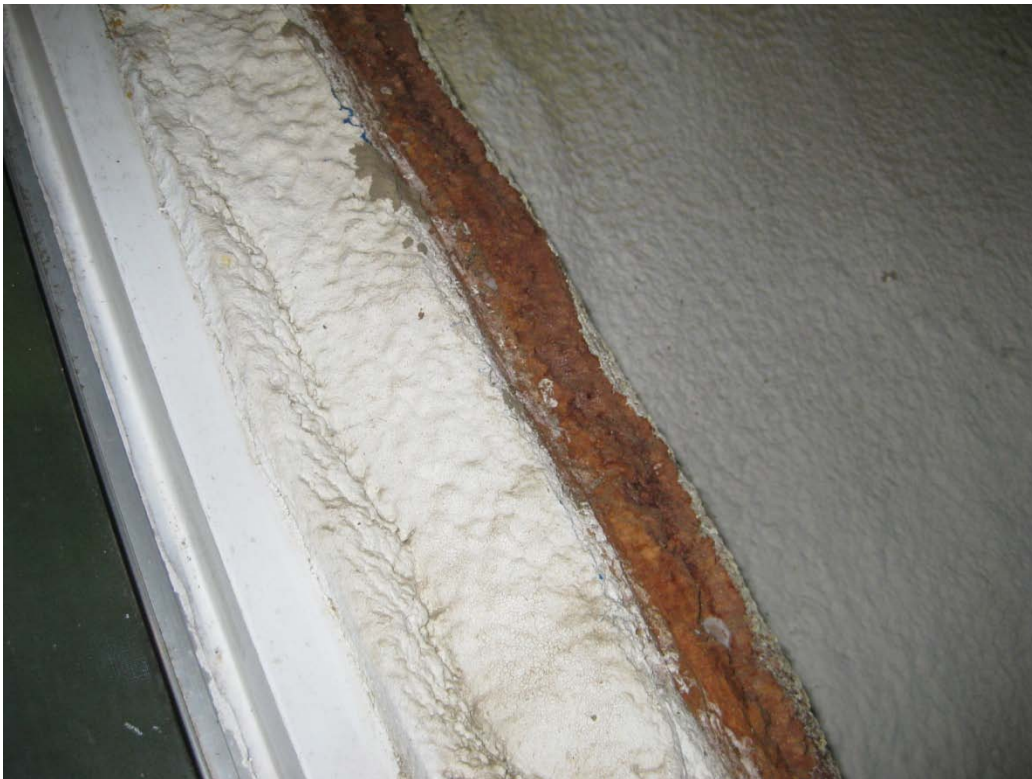
Picture 15: Exposed Foam 1

5. ****Wall cracks and exposed structural foam noted (Picture 15 Exposed Foam 1)**
Corrective Action:
Repair cracked walls. If foam is structurally sound and not crumbling or flaking, replace missing foam and properly seal walls to enable cleaning and to retard moisture intrusion from showers and baths.

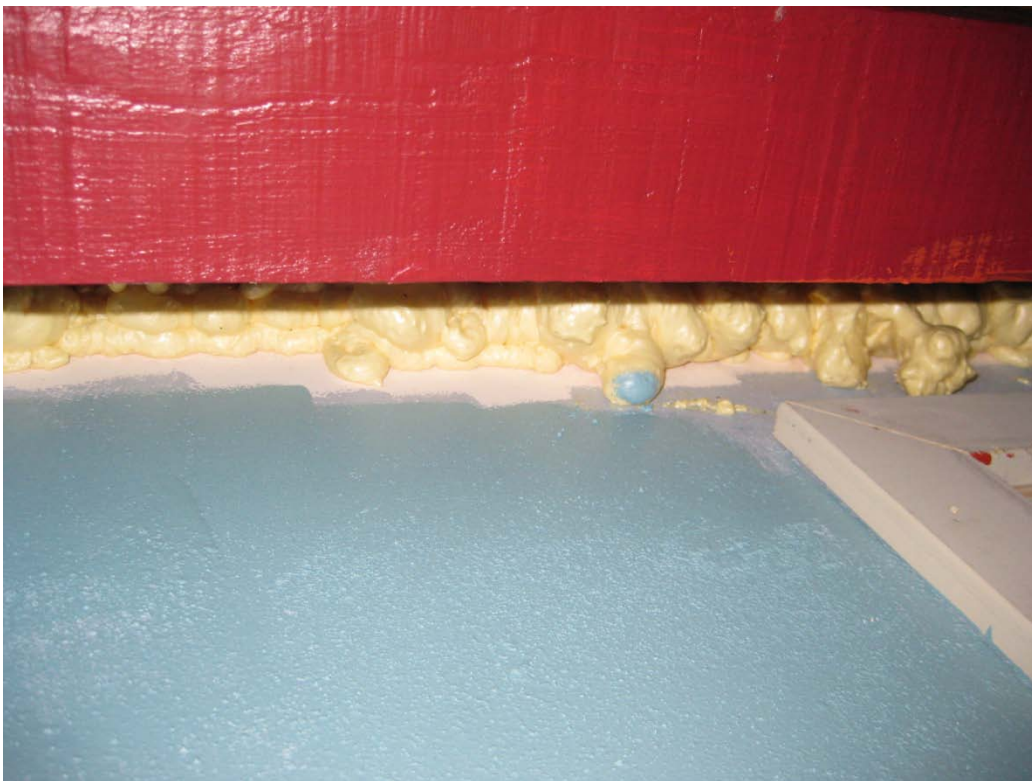
Picture 17: Foam 2

5. ****Foam fill is exposed between the loft and wall near the doorway closest to hallway. (Picture 17: Foam 2)**

Seal foam for cleaning and to prevent flaking/chipping.

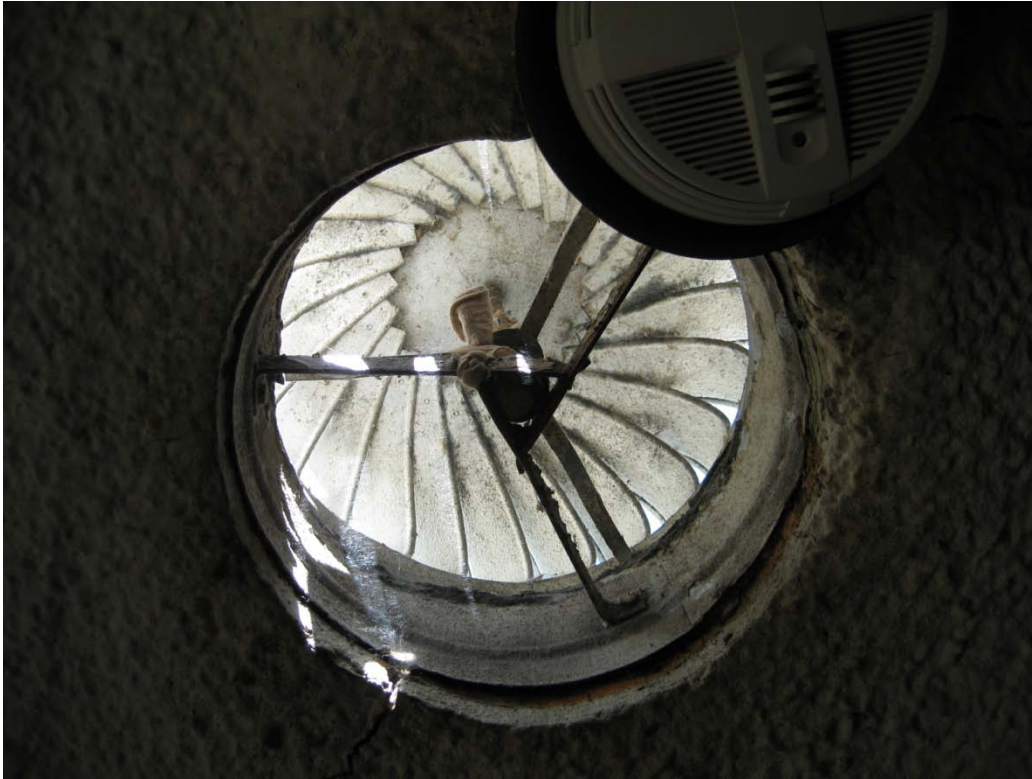
Picture 18: Vent

1. Passive building fan located at the apex of the dwelling is not secured against the entry of rodents, insects or other pests. (Picture 18: Vent)

Install material (e.g., metal screen) to prevent entrance of insects, rodents and other pests.

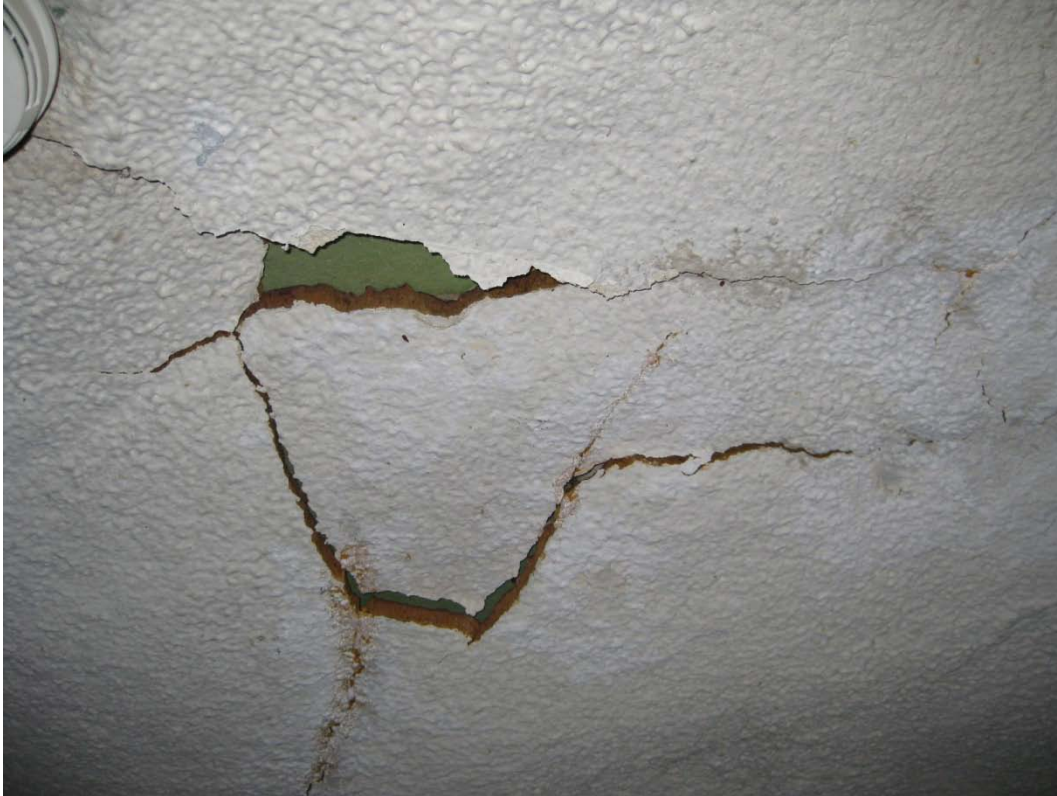
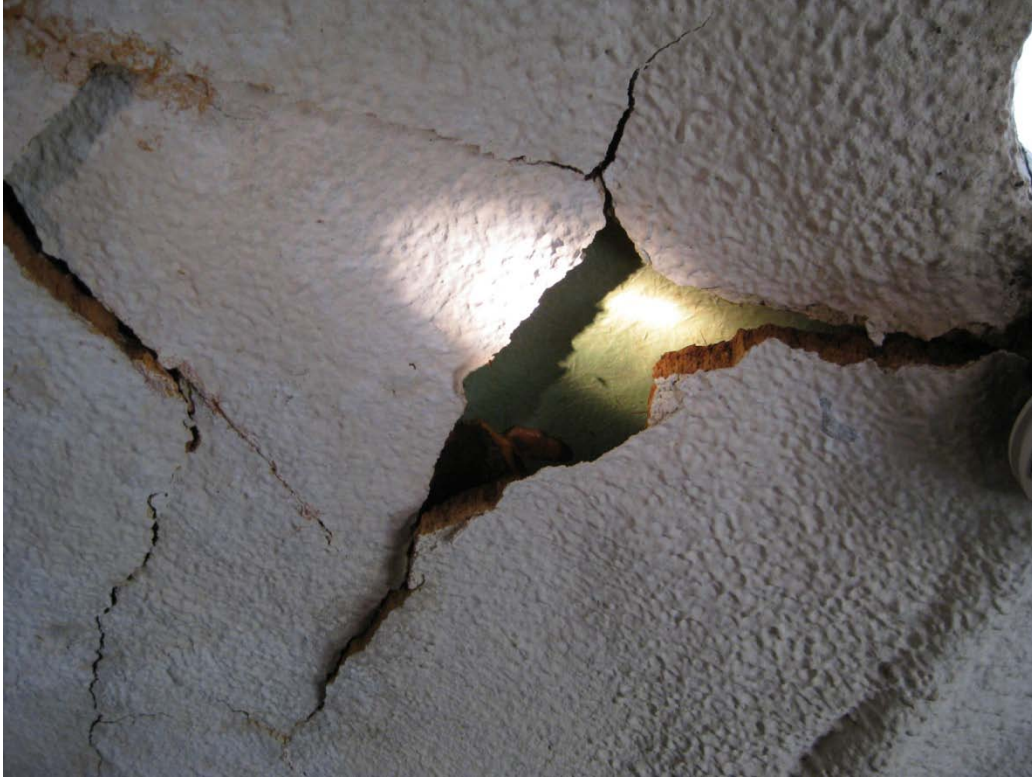
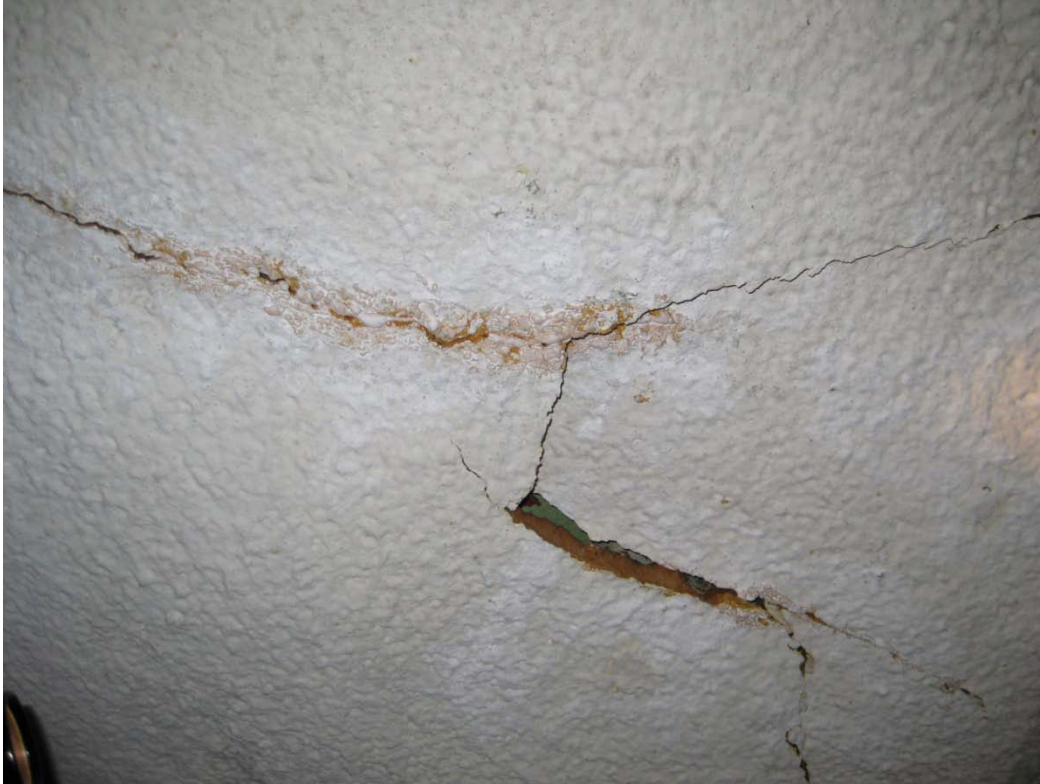
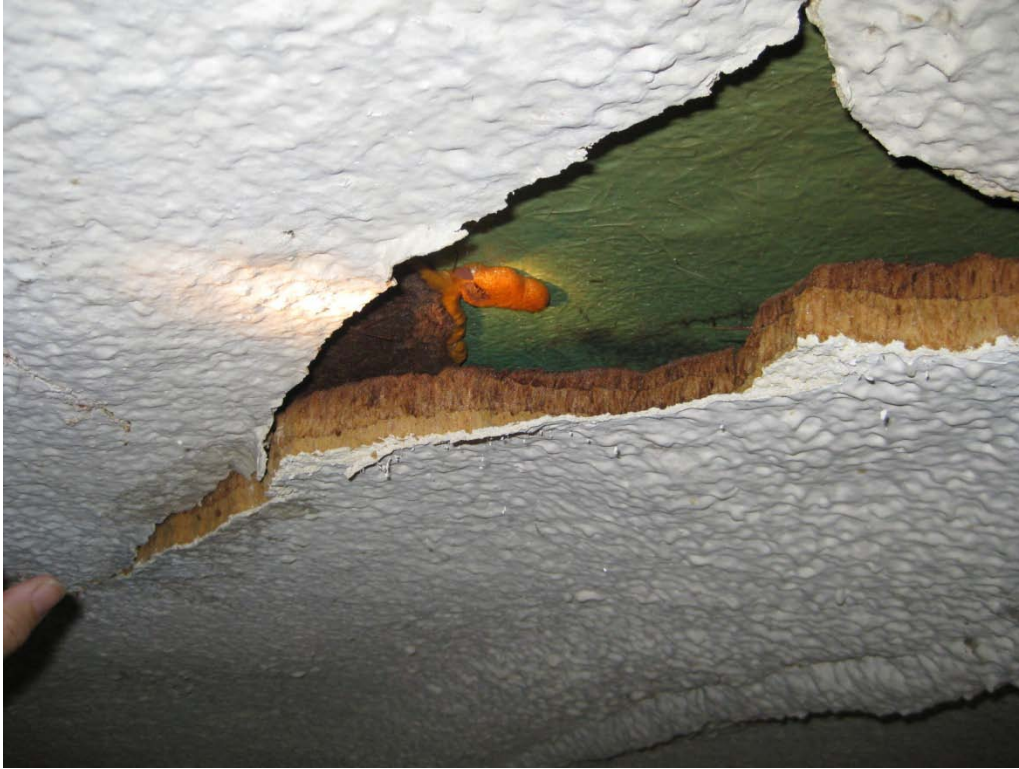
2. ****Significantly heat, light and water damage and deterioration of structural foam and interior ceiling material (most) noted near and around the building fan. (Pictures 19-22)**

4. **** A number of interior wall cracks were noted including one located to the right of the fire alarm; goes to bathroom. It is unknown if the crack affects the operation of the alarm. (Picture 19: Ceiling Damage)**

*Identify and correct all problems leading to water intrusion. If foam is structurally sound, can be made to discontinue crumbling or flaking and can be fully replaced, replace missing foam and interior (and if needed, exterior) ceiling (roof) material. Be sure to seal the material with an approved substance in a manner that eliminated UV/Sun deterioration **NOTE:** All work must be pre-approved, in writing, by the appropriate UC Davis Student Housing Representative and when required, by UC Davis Fire Department and EH&S. Also, all work must be performed by a State Licensed contractor for whom written approval has been obtained from UC Davis Student Housing.*

*Corrective Action: Identify and correct reason(s) for cracks and repair as required. all problems leading to water intrusion. If foam is structurally sound, can be made to discontinue crumbling or flaking and can be fully replaced, replace missing foam and interior (and if needed, exterior) ceiling (roof) material. Be sure to seal the material with an approved substance in a manner that eliminated UV/Sun deterioration **NOTE:** All*

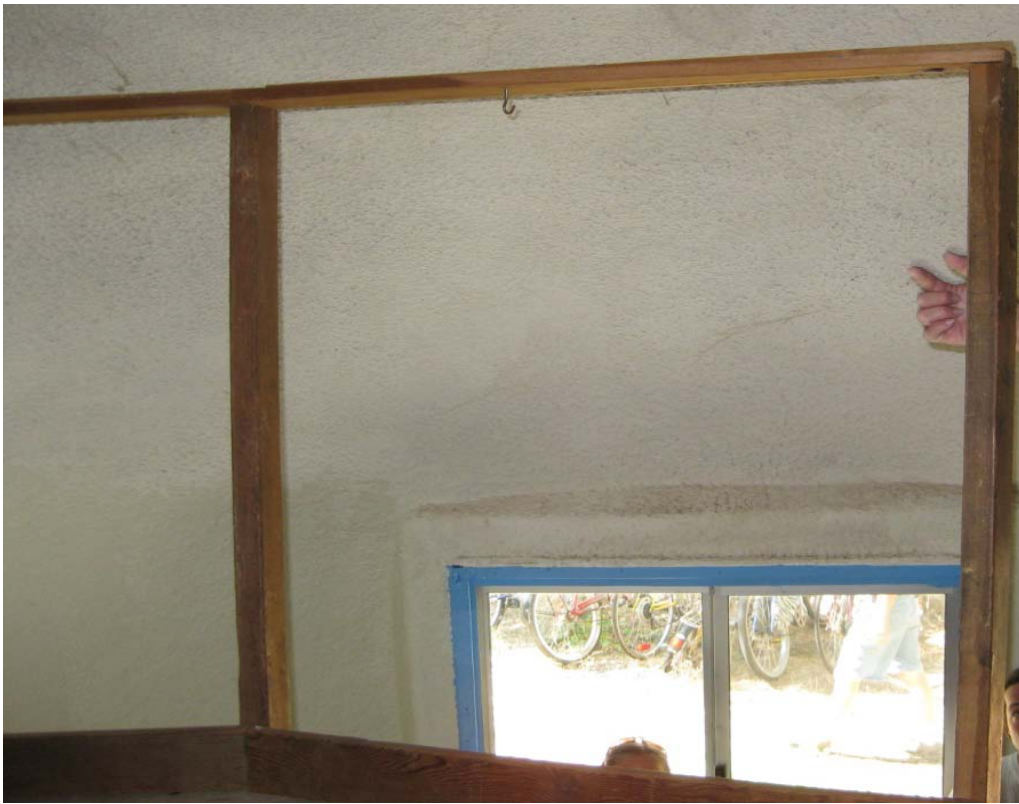
Picture 23: Handrail

3. ****Railing at edge of loft is not secure and is not constructed in accordance with minimum Building Code Requirements. (Picture 23: Handrail)**

*With written approval and guidance from UC Davis Student Housing, retain the services of a State Licensed (Construction) Contractor who will provide for the construction of a railing that meets Code. Plans must be submitted to UC Davis Student Housing who will route them in accordance with Campus requirements. **NOTE:** All work must be pre-approved, in writing, by the appropriate UC Davis Student Housing Representative and when required, by UC Davis Fire Department and EH&S. Also, all work must be performed by a State Licensed contractor for whom written approval has been obtained from UC Davis Student Housing.*

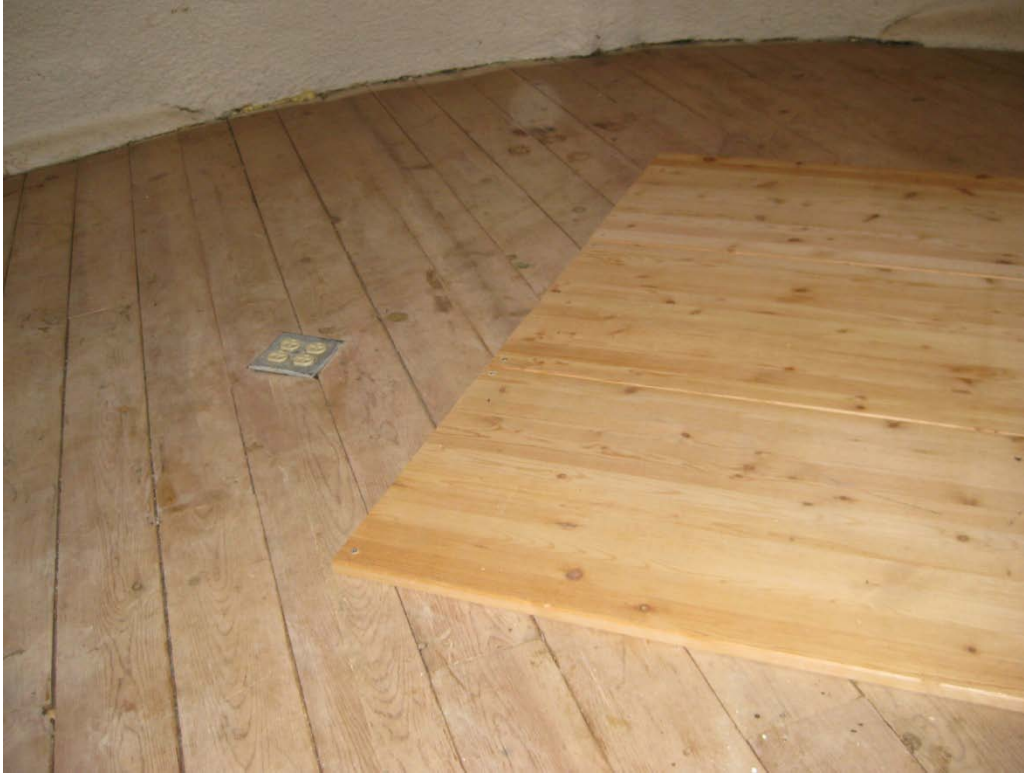
Picture 24: Loft Floor

5. ****Electrical outlet box installed on floor may not be to code and poses trip and electrical hazards. (Picture 24: Floor)**

6. ****Wooden pieces of wood are secured to, and covering, a section of the loft bedroom. The wooden pieces are elevated above floor level creating a trip hazard. (Picture 24)**

Retain the services of a State Licensed electrician, or an electrician from, or approved by Student Housing or the campus Electrical Shop to determine if electrical outlet is properly installed and in good repair. If so, re-install so that outlet cover does not sit on wooden surface and so supply cords do not present a tripping hazard.

Identify the reason the wood was installed to determine if repairs are needed. With written approval and guidance from UC Davis Student Housing (SH), retain the services of a State Licensed (Construction) Contractor and a State Licensed Engineer who will determine if loft is built according to code for the intended use(s).

*If loft is not built to code, either remove (under guidance of SH) or work with the (SH approved) contractor/engineer to design and draw plans for loft. The plans must be submitted to SH for review and approval by (at a minimum) Campus SH, EH&S and Fire. Prior to removing or rebuilding, all work must have a written pre-approval from the appropriate Student Housing Representative. **NOTE:** All work must be performed by a State Licensed contractor for whom written approval has been obtained from UC Davis Student Housing.*
