## Dome Fiberglass Summary

# Fiberglass Coupon Test Results

prepared by: Prof. Lijuan “Dawn” Cheng’s Composite Lab  
Department of Civil and Environmental Engineering, UC Davis

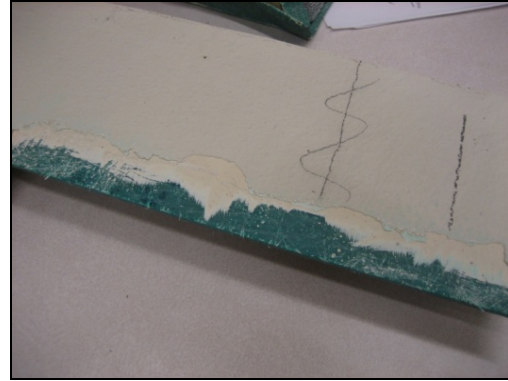
**Figure 3 - Additional sanding after paint removal**

Since the middle layer of the specimen was the fiberglass structural layer that was needed for testing, the insulation and the paint layers were removed first. The paint layer of the raw sample was removed with flathead screw driver or a chisel, and rough sand paper to get rid of the residuals. Over the years, The Domes have received several fresh coatings of paint, so the outer paint layer actually consisted of many thinner paint layers. Shown in Figure 2, most of the paint was easily removed with the hand tools. The paint nearest the fiberglass, however, was a thin latex layer. This layer was sanded away to reveal the fiberglass beneath it, as shown in Figure 3.

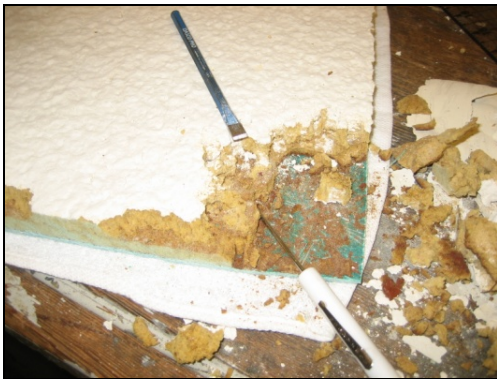
**Figure 4 - Insulation removal**

After the paint layer was removed, the insulation foam was then removed only from an area of fiberglass that was sufficiently large enough to make test specimens. Although the foam was easily removed, several patches of adhesive residue remained in the natural valleys formed by the chopped fibers. To avoid potential bonding issues later in the sample preparation, the remaining patches of residue were sanded away as much as possible. Figures 4 and 5 show the foam removal and fiberglass surface, respectively.

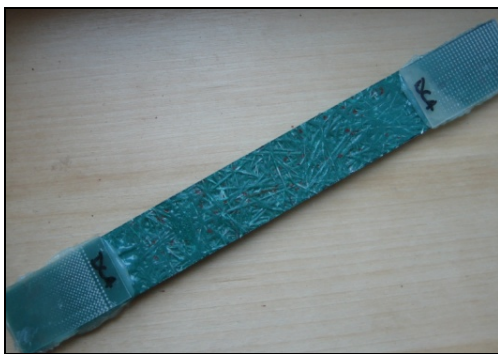
**Figure 6 - Coupon Specimen**

Following sanding, the sanded sample area was cut into 6 standard coupon strips (1×10") for ASTM tensile testing using a model MK-100 Tile Saw in the Composite Lab at CEE. To aid in the proper transfer of forces to the specimens, tabs made of glass fiber were made to both ends of each coupon strip. The tabs were then applied to the top and bottom ends of each coupon, as shown in Figure 6.

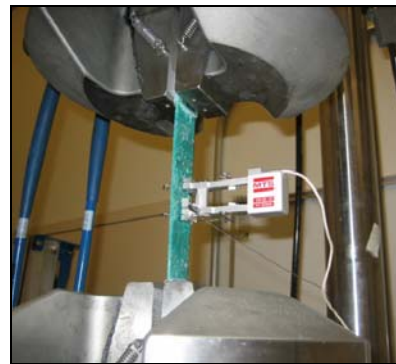
**Figure 7 - Coupon test setup**

All tensile tests were conducted using an 810 Material Testing System available at CEE, shown in Figure 7. Specimens 1, 2, 3, 5, and 6, were each loaded successfully to failure (Specimen 4 failed unexpectedly due to some error). Figure 8 shows the typical failure on the front and back sides of the specimens. The test results are summarized in Table 1 below, where **the average tensile strength of the coupons was 49.03 MPa and the average tensile modulus was 7.71 GPa.**
