RE: July 14, 2010 Inspection of Baggins End Dome # 10

On Wednesday, July 14, 2010 at the Request of Student Housing and as part of a joint inspection team that included UCD Fire, Design and Construction Management and Facilities Services, Susan Cummings, Claire Denham and Sue Fields of EH&S performed an inspection of the unoccupied Dome 10 in Student Housing's Baggins End Housing Area.

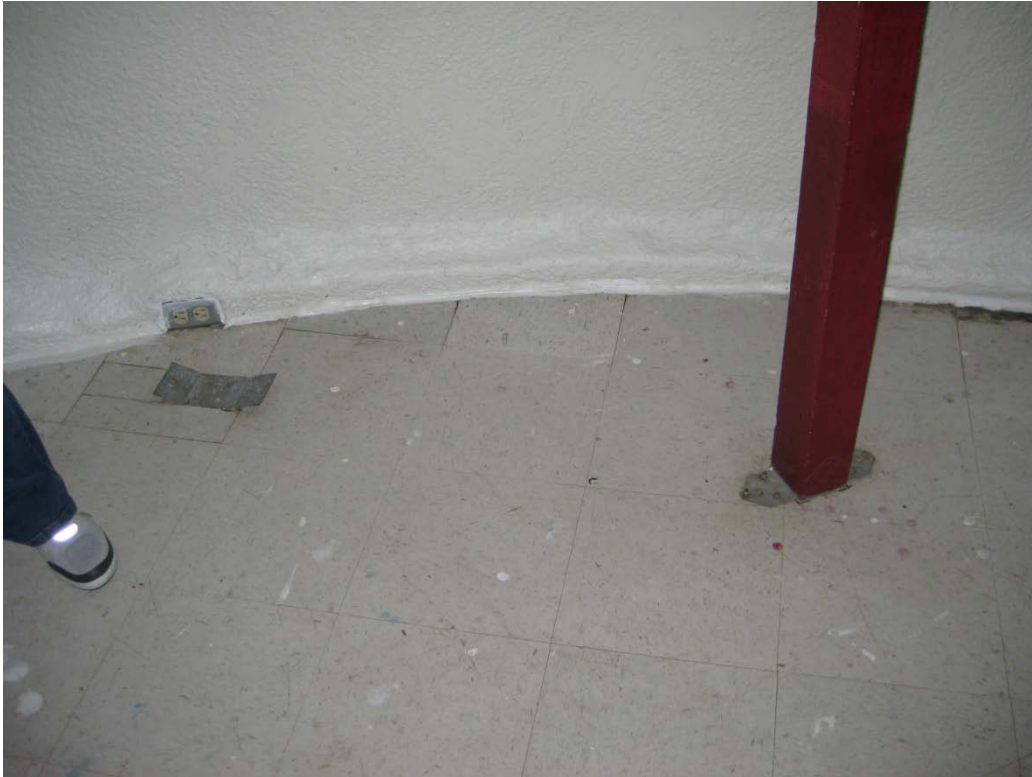
Picture 15: Exposed Foam 1

5. ****Wall cracks and exposed structural foam noted (Picture 15 Exposed Foam 1)**
Corrective Action:
Repair cracked walls. If foam is structurally sound and not crumbling or flaking, replace missing foam and properly seal walls to enable cleaning and to retard moisture intrusion from showers and baths.
